NMPSIA

Espanola Public Schools

Alcade Elementary School

Loss Control & Safety Audit

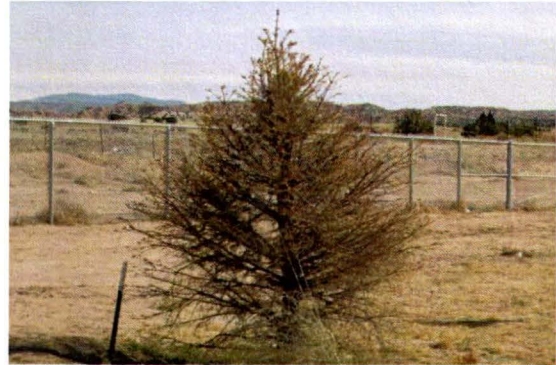
Recommendation Number: 2014-001

1. Is turf in good condition; is landscape well-groomed and free of overhang, concealment, or other potential hazards?

- Several dead trees were observed.

- Remove/replace dead vegetation.

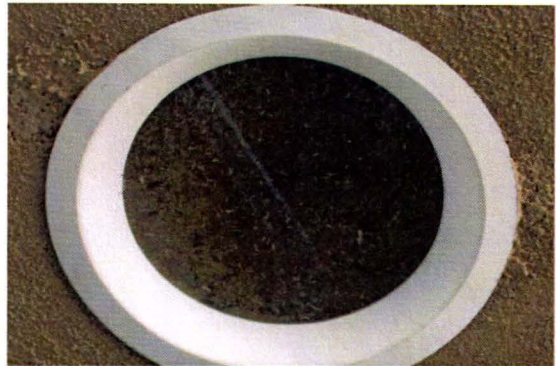
Recommendation Number: 2014-002

2. Does interior and exterior lighting appear to be adequate, and are lighting fixtures in good condition?

- Some areas appeared to have inadequate illumination.
- Low illumination from some light fixtures caused by accumulation of dead insects.

- Light fixtures should be cleaned and sealed as necessary.

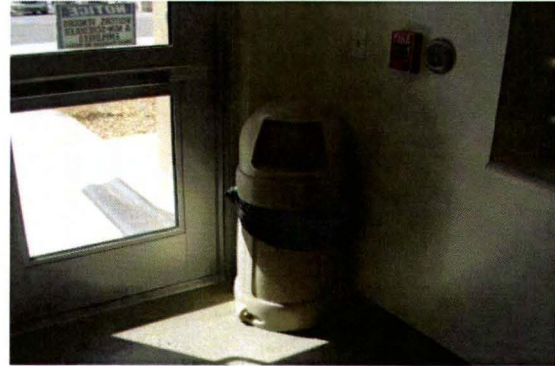
Recommendation Number: 2014-003

3. Are exits and exit paths unobstructed and regularly inspected, and are doors free of inappropriate locks?

- One or more exit aisles, doors, and/or pathways were obstructed.
- These obstructions may prevent quick and safe egress in an emergency.

- Obstructions should be removed.
- A minimum clearance that is equal to the width of the door and six feet deep must be maintained on both sides of an exit.
- An access route to this clear space must be maintained at all times.

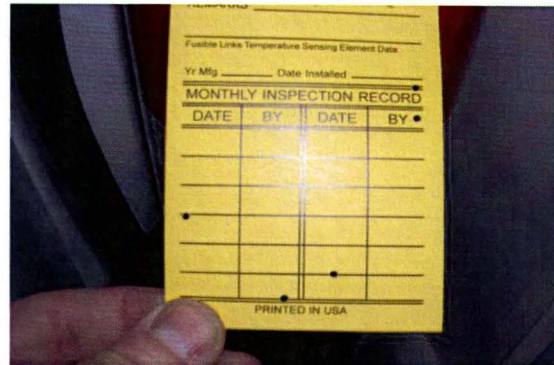
Recommendation Number: 2014-004

4. Are the appropriate types of fire extinguishers properly installed, unobstructed, inspected on a monthly and annual basis, and equipped with service tags?

- Monthly fire extinguisher inspections are not being conducted.

- The fire extinguishers should be inspected on a monthly basis to ensure that:
 - they are properly wall mounted;
 - the seals and pull pins are still intact;
 - and
 - the units are fully charged and ready for use.
- The monthly inspection should be documented with the inspector's initials on the back of the annual inspection tag.

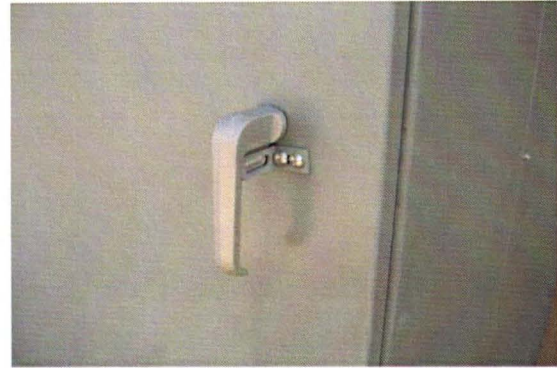
Recommendation Number: 2014-005

5. Are electrical panels and utility shutoff switches and valves unobstructed, properly labeled or identified, and protected from tampering; and do visible system components appear to be in good condition?

- The boxes were not locked to prevent unauthorized access.

- All exterior utility controls should be covered and locked, or otherwise controlled, to prevent unauthorized access.

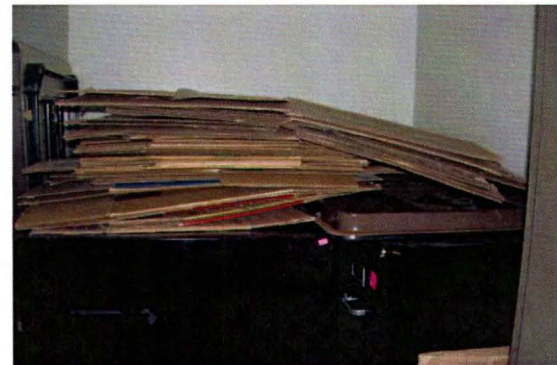
Recommendation Number: 2014-006

6. Are storage areas uncluttered with adequate aisles maintained, and is overhead storage secured with sufficient clearance to the ceiling or sprinkler heads?

- The housekeeping needed improvement in some places.

- The area should be maintained in a neat and orderly manner, free from any condition that would create a fire or life hazard or a condition which would add to or contribute to the rapid spread of fire.
- All areas should be cleaned and organized to reduce injury and property damage hazards.

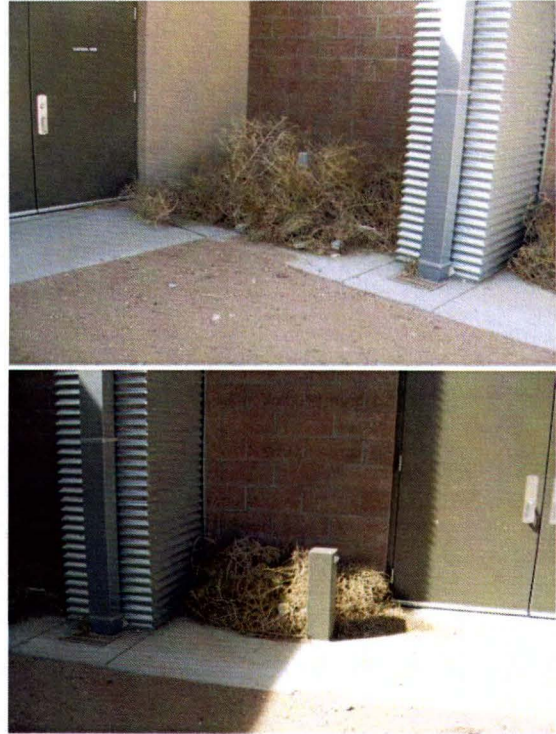
Recommendation Number: 2014-007

7. Is the premises free of the accumulation of trash, debris, or the unsafe storage of combustibles?

- Trash and debris were strewn around some areas of the campus.

- Frequent, at least daily, inspections of the grounds should be made to find and remove debris and trash.
- Since debris tends to attract more debris, it should be removed promptly upon discovery.

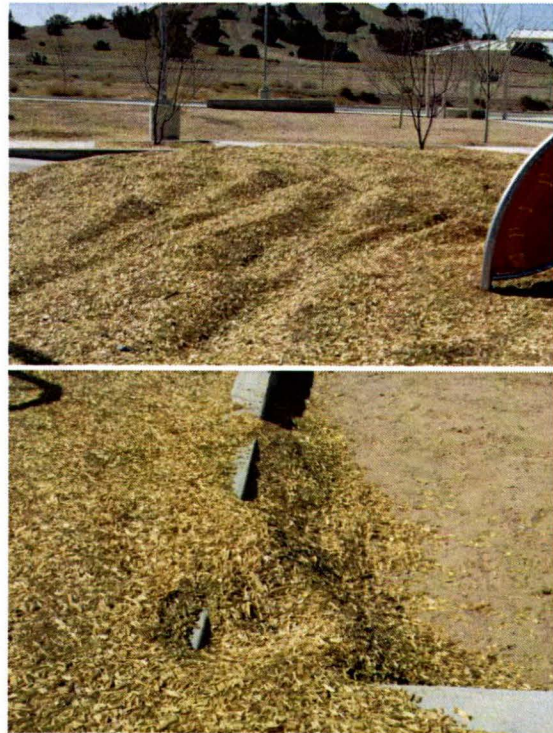
Recommendation Number: 2014-009

1. Are playground structures equipped with a shock absorbing surface of an appropriate type and depth beneath them?

- The protective surfacing around and under the equipment was too deep in some areas and was overflowing the barrier.

- Protective surfacing should be installed and maintained throughout the entire use zone of the equipment being protected.
- The protective surfacing should be maintained in all areas of the equipment use zone so that it provides adequate protection for the maximum height of the equipment.

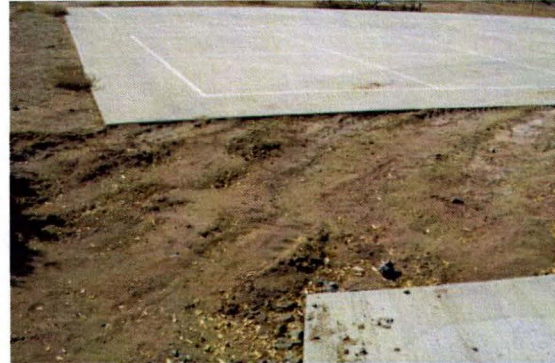
Recommendation Number: 2014-010

2. Is an accessible path provided to all play structures, and are an appropriate number of play events provided for persons with disabilities?

- Accessible path requires transition from concrete through dirt to ramp.

- An accessible route to the playgrounds and an accessible protective surfacing material should be provided to all playgrounds in accordance with the performance requirements of Specifications F1951 of the ASTM and the Play Area Accessibility Guidelines of the United States Access Board.

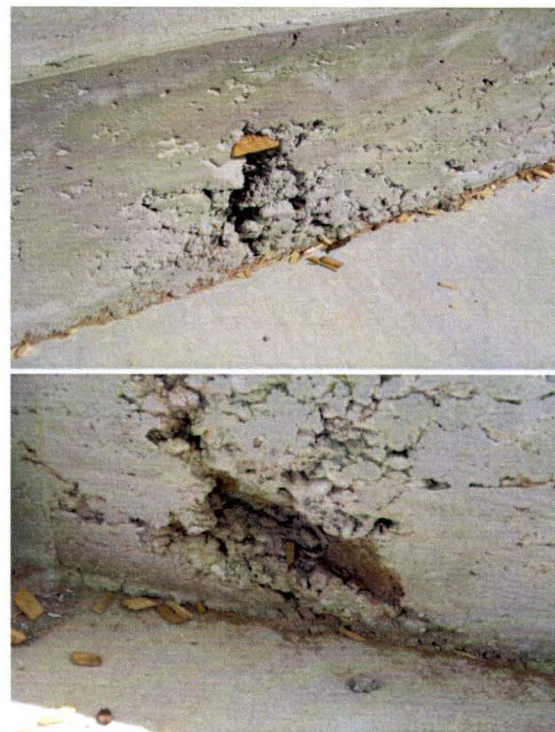
Recommendation Number: 2014-011

3. Are playgrounds, play areas, and equipment otherwise free of apparent hazards?

- Concrete playground surfacing barrier/berm was cracked and damaged.
- Continued deterioration could lead to more damage and trip/fall hazards.

- Repair as necessary.
